COAL CAR HISTORIC RECONSTRUCTION

Idiosyncrasies and Anomalies

March 10, 2008

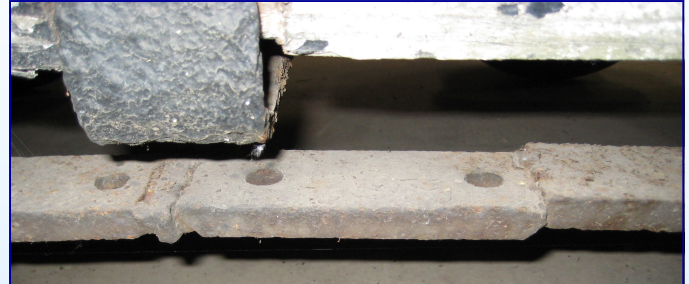
At some point in its history, the body of the coal car was lengthened. This photo shows the welded 6-inch piece that was added to the frame of the car.

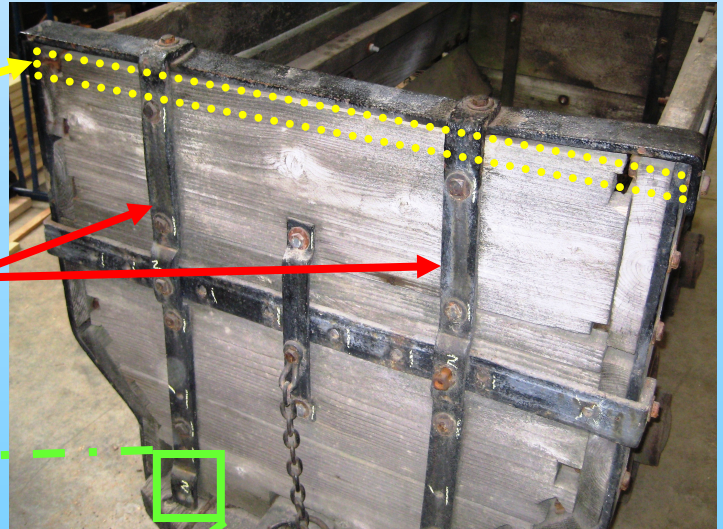
The strap that is currently on top of the end of the coal car would have been on the front of the car, as shown by the yellow dotted lines.

The two vertical straps on the end of the coal car are currently on upside down. During the reconstruction, they will be flipped 180° and re-attached.

We really had to put our heads together on this one to decide whether to fix this anomaly or leave it—were the straps accidentally reversed the last time the car was rebuilt by the Museum, or was this an earlier mistake, made at the mine? Ultimately we decided that since the car would have broken down pretty quickly if this had been an early mistake, the straps should be put back on correctly this time.

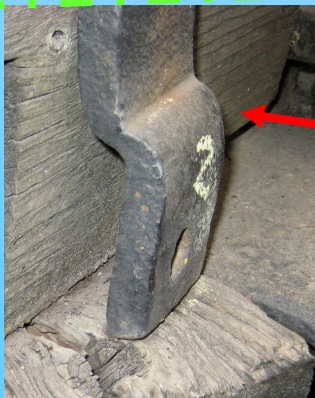
This photo shows the bottom of one of the vertical straps that is on upside down. The bend in the metal was one clue that something was not quite right with the way the straps were attached.
